Flood Control Project Maintenance
2010 Structure Summary Report
Overall Unit and Item Ratings

Madera County FCWCA

Ash And Berenda Slough Control Structures

Fresno River Diversion Weir

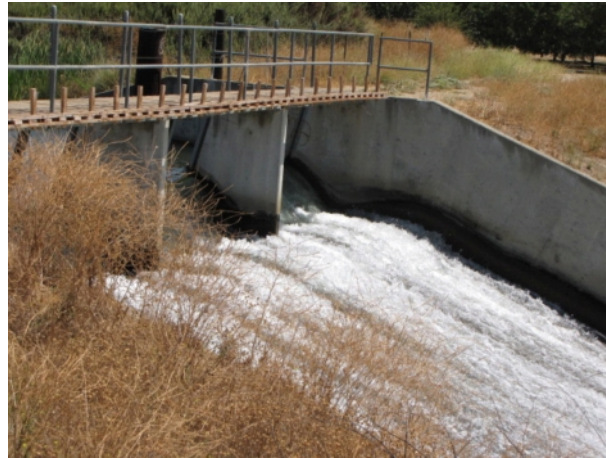
Levee Mile Report Line	1
Start Levee Mile	0.00
End Levee Mile	0.00
Location	Land Side
Category	Structures
Item	Photo Documentation
Standing on downstream right bank of Berenda slough. 37.15813N -120.12439W	
phillips_t_20100823_015.jpg

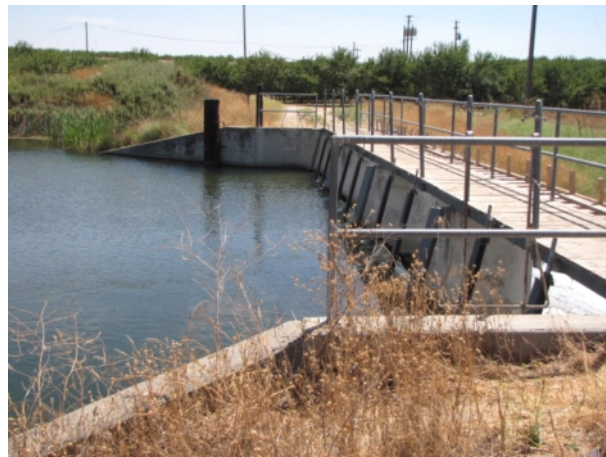
Levee Mile Report Line	1
Start Levee Mile	0.00
End Levee Mile	0.00
Location	Land Side
Category	Structures
Item	Photo Documentation
Standing on right bank upstream of structure.	
phillips_t_20100823_016.jpg

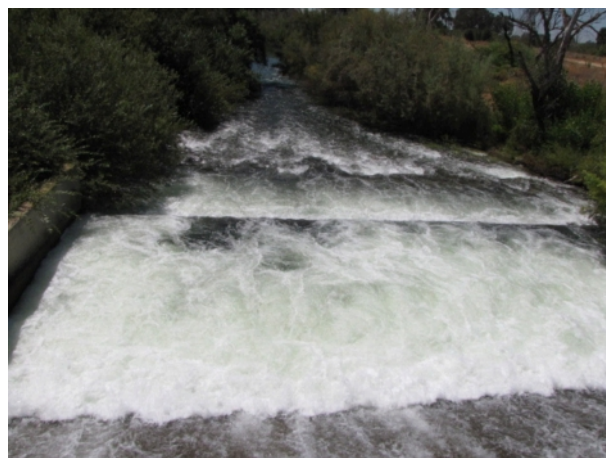
Levee Mile Report Line	2
Start Levee Mile	0.00
End Levee Mile	0.00
Location	Land Side
Category	Structures
Item	Vegetation & Obstructions
Downstream of Berenda Slough control structure. No veg.	
phillips_t_20100902_043.jpg

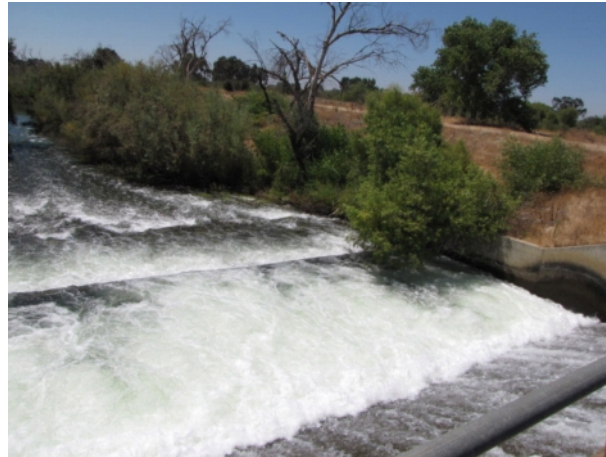
Levee Mile Report Line	2
Start Levee Mile	0.00
End Levee Mile	0.00
Location	Land Side
Category	Structures
Item	Vegetation & Obstructions
Looking at R/B of Berenda Slough, no veg obstruction in channel.	
phillips_t_20100902_044.jpg

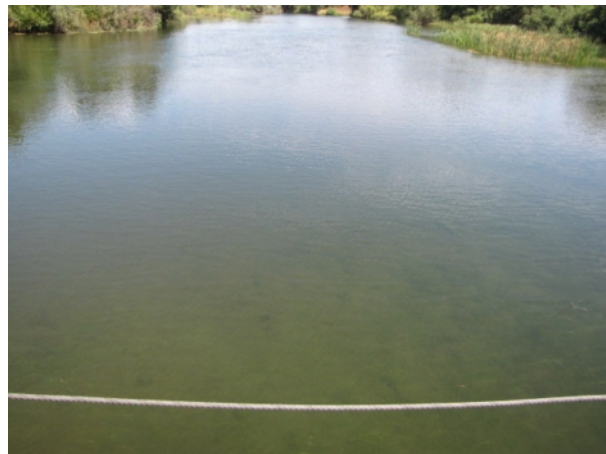
Levee Mile Report Line	2
Start Levee Mile	0.00
End Levee Mile	0.00
Location	Land Side
Category	Structures
Item	Vegetation & Obstructions
Looking upstream of Berenda.	
phillips_t_20100902_045.jpg

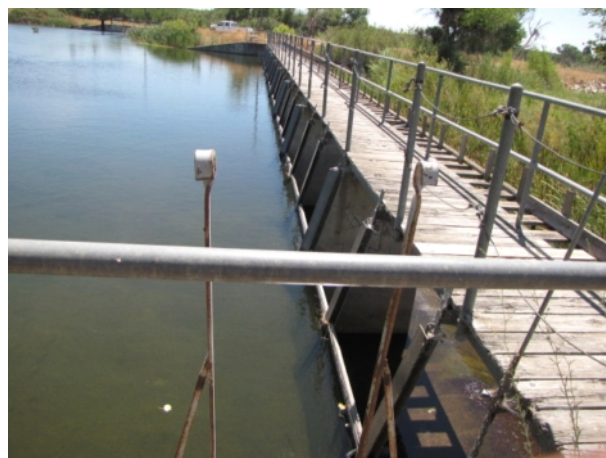
Levee Mile Report Line	2
Start Levee Mile	0.00
End Levee Mile	0.00
Location	Land Side
Category	Structures
Item	Vegetation & Obstructions
Looking up stream of Ash Slough.	
phillips_t_20100902_046.jpg

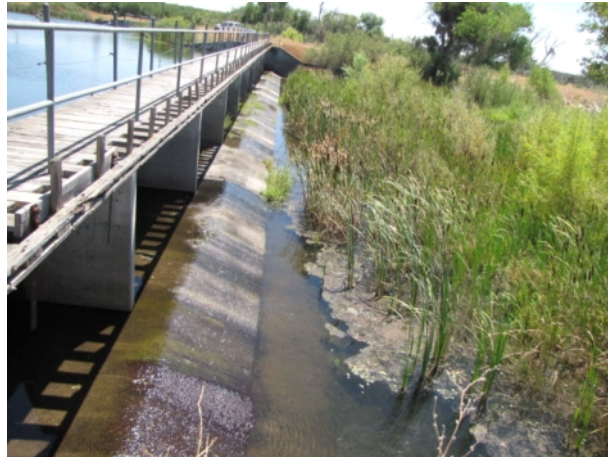
Levee Mile Report Line	17
Start Levee Mile	0.00
End Levee Mile	0.00
Location	Land Side
Category	Structures
Item	Concrete Foundations
<p>This photo shows the concrete structure of Ash from downstream R/B of structure. 37.19352N - 120.56293W.</p> <p>phillips_t_20100902_042.jpg</p>

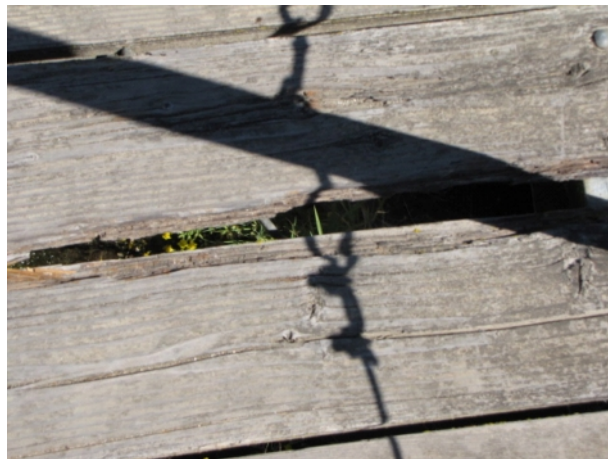
Levee Mile Report Line	23
Start Levee Mile	0.00
End Levee Mile	0.00
Location	Land Side
Category	Structures
Item	Safety
<p>Board damage on cat walk. This photo was taken 2009.</p> <p>phillips_t_20100812_006.jpg</p>

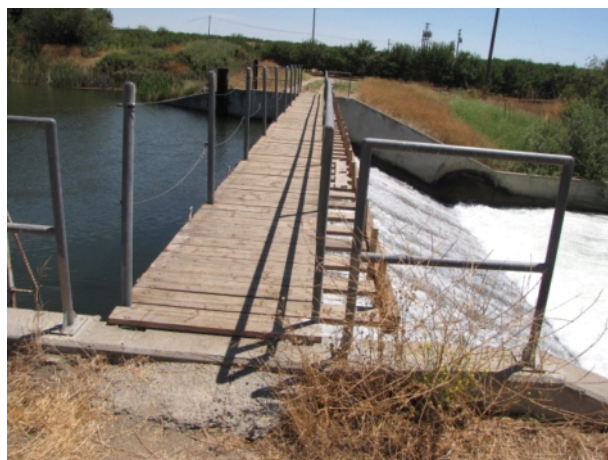
Levee Mile Report Line	23
Start Levee Mile	0.00
End Levee Mile	0.00
Location	Land Side
Category	Structures
Item	Safety
<p>This photo shows where the broken boards from last years inspection has been replaced with new materials. You can also see the safety cables across the walk way.</p> <p>phillips_t_20100902_041.jpg</p>

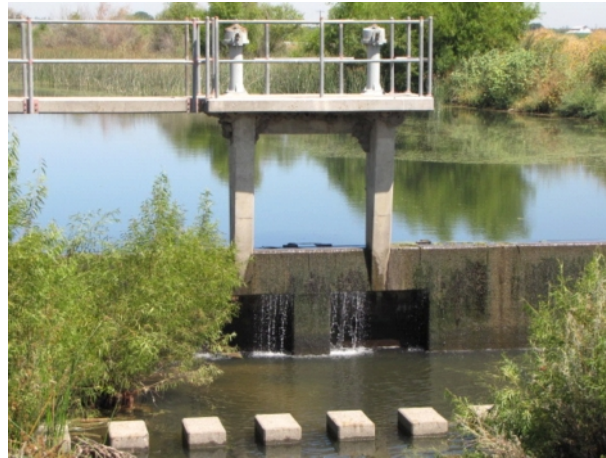
phillips_t_20100831_018.jpg

Looking at the downstream end of the Fresno control structure.

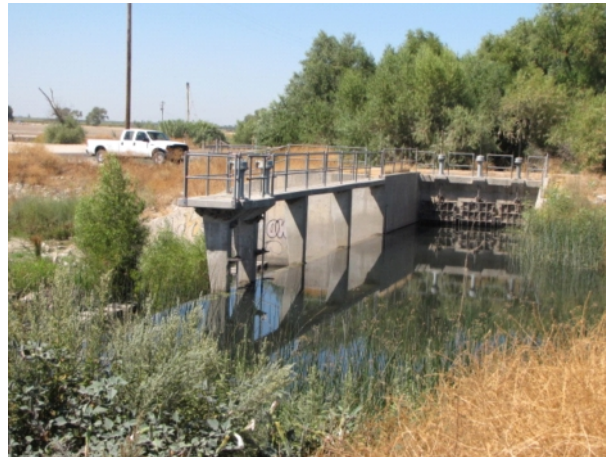
phillips_t_20100831_020.jpg

From this angle on unit 6 you can see the growth in the downstream end of structure. Trees that should be removed.

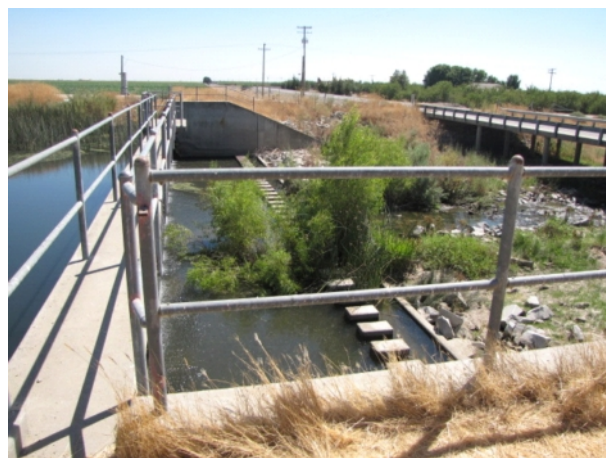
phillips_t_20100831_021.jpg

From RB downstream view of growth in outlet end of structure. View here also shows the walk way with safety railing if place.

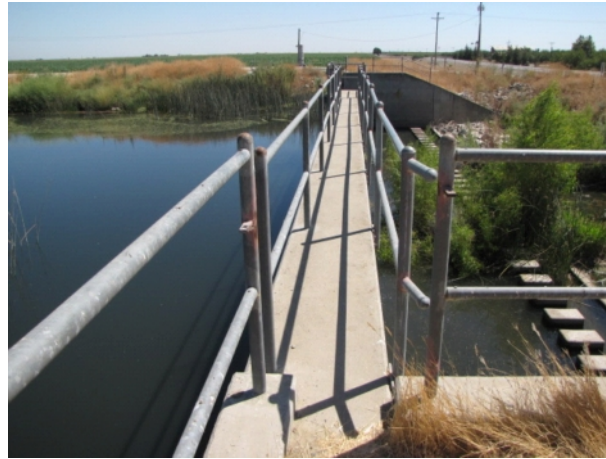
phillips_t_20100831_022.jpg

View of safety railing and walk way.

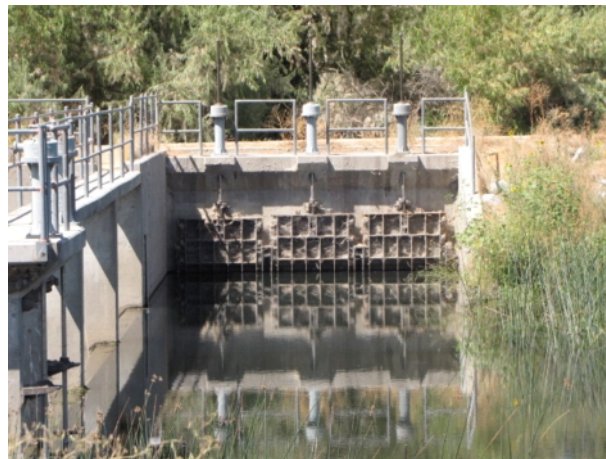
phillips_t_20100901_026.jpg

Manual gates are in good condition viewed from L/B Unit #6.

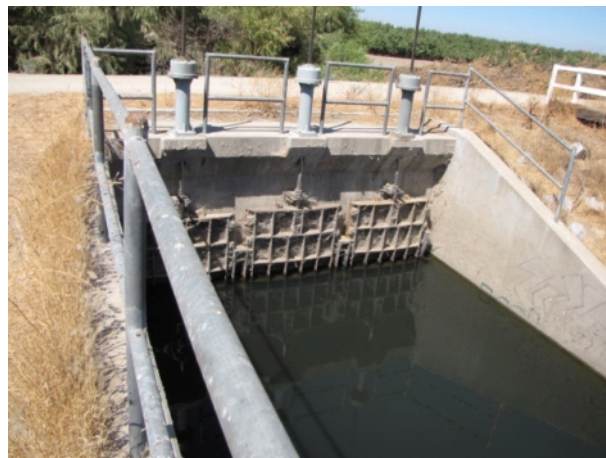
phillips_t_20100901_027.jpg

Another view of the manual screw gate viewed from walk way.

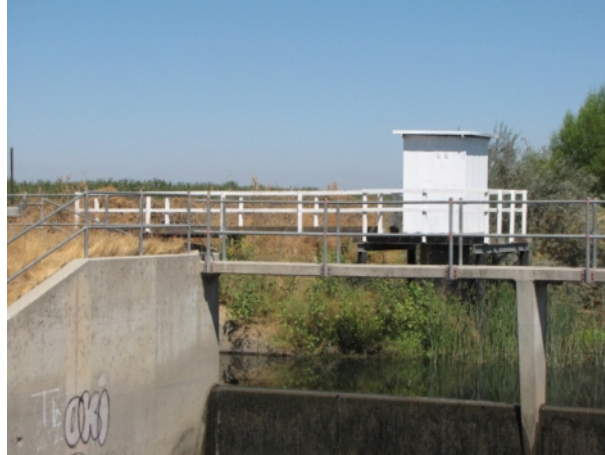
Levee Mile Report Line	22
Start Levee Mile	0.00
End Levee Mile	0.00
Location	Land Side
Category	Structures
Item	Safety
View of both walkways, safety railings in good shape.	
phillips_t_20100901_029.jpg
